EXAMINATION OF CORRODED TUBES FROM THE BOILERS OF THE USS EDWARDS (DD-950)

August 1959

U. S. NAVAL RESEARCH LABORATORY
Washington, D.C.

NRL MEMORANDUM REPORT 964

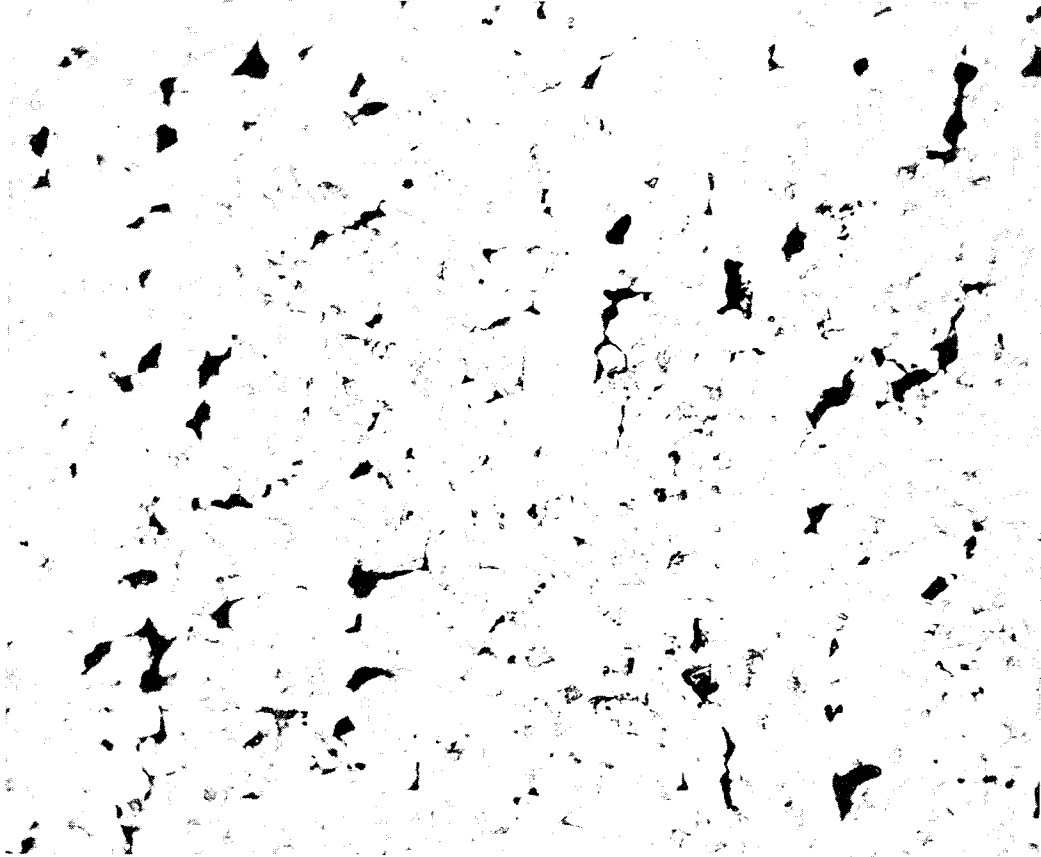
The generating tube failures were characteristically highly localized bulges terminating in ruptures. The ruptures can be identified as resulting from a relatively slow process (creep) and not from a momentary stoppage of circulation. Part of the evidence for this is the multiple grain-boundary voiding of Figure 1. Both Fig. 1 and Fig. 2 clearly demonstrate that the tube at that point was well in excess of 1335°F. One bulge which had not ruptured was sectioned (Fig. 3) and indicated that it too had been heated above 1335°, but probably not as high as the area of Fig. 1. The areas of overheating and bulging coincided exactly. A short distance away from a bulge there was no evidence of partial austenitization (Fig. 4). The tube wall was considerably reduced in thickness along the cylindrical element containing the bulges by a water-side reaction, and a thick white deposit coated that area. The deposit was especially thick at the bulges (Fig. 5). In boiler 1B this thick white layer was covered by a dark deposit of normal boiler-corrosion products.

- Fig. 1 - 1B Boiler - RW No. 21 (Section through bulge that cracked). Note grain-boundary voids which are a result of prolonged exposure to high temperatures and stress. Etchant: 1% Nital. 500X.

Fig. 1 - 1B Boiler - RW No.21 (Section through bulge that cracked). Note grain-boundary voids which are a result of prolonged exposure to high temperatures and stress. Etchant: 1% Nital. 500X.

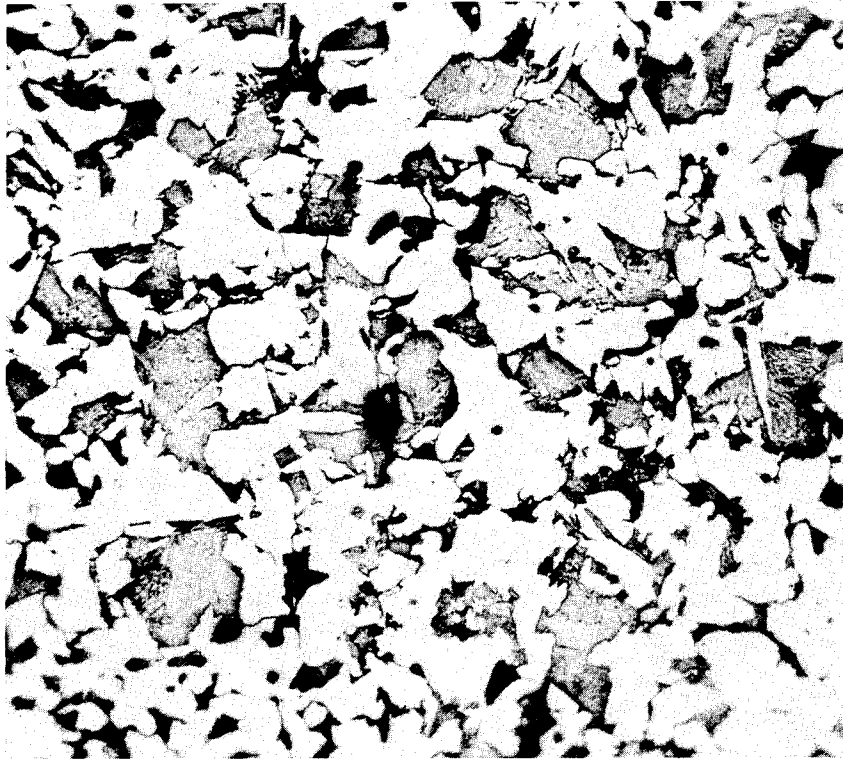
- Fig. 2 - 1B Boiler - RW No. 21 (Section through bulge that had cracked). Notice structure indicating that metal was rapidly cooled from temperature above 1335°F when the tube failed. Etchant: 1% Nital. 1000X.

Fig. 2 - 1B Boiler - RW No.21 (Section through bulge that had cracked). Notice structure indicating that metal was rapidly cooled from temperature above 1335° F when the tube failed. Etchant: 1% Nital. 1000X.

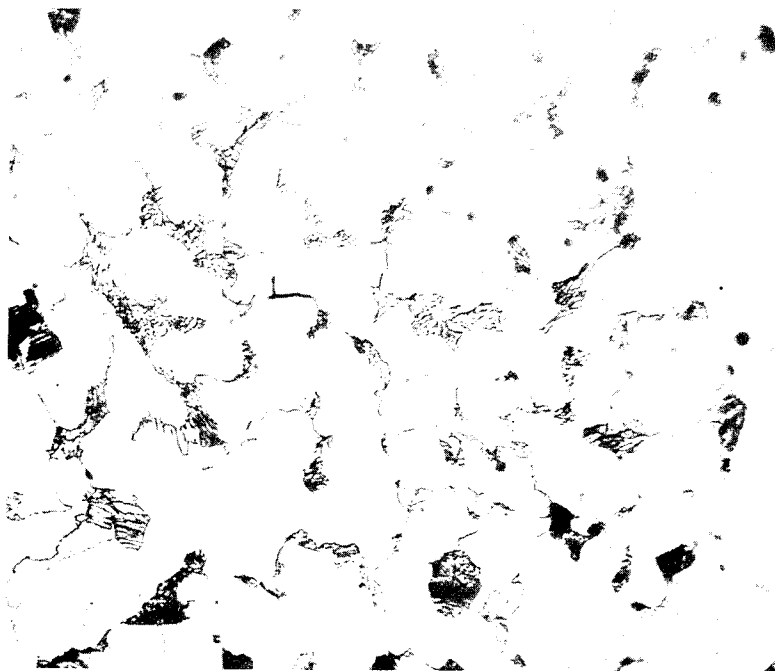
- Fig. 3 - 1B Boiler - RW No. 18 (Section through bulge that had not cracked). Note lamellar (new) pearlite which indicates that service temperature exceeded 1335°F. Etchant: 1% Nital plus 2% Picral. 1000X.

Fig. 3 - 1B Boiler - RW No.18 (Section through bulge that had not cracked). Note lamellar (new) pearlite which indicates that service temperature exceeded 1335⁰F. Etchant: 1% Nital plus 2% Picral. 1000X.

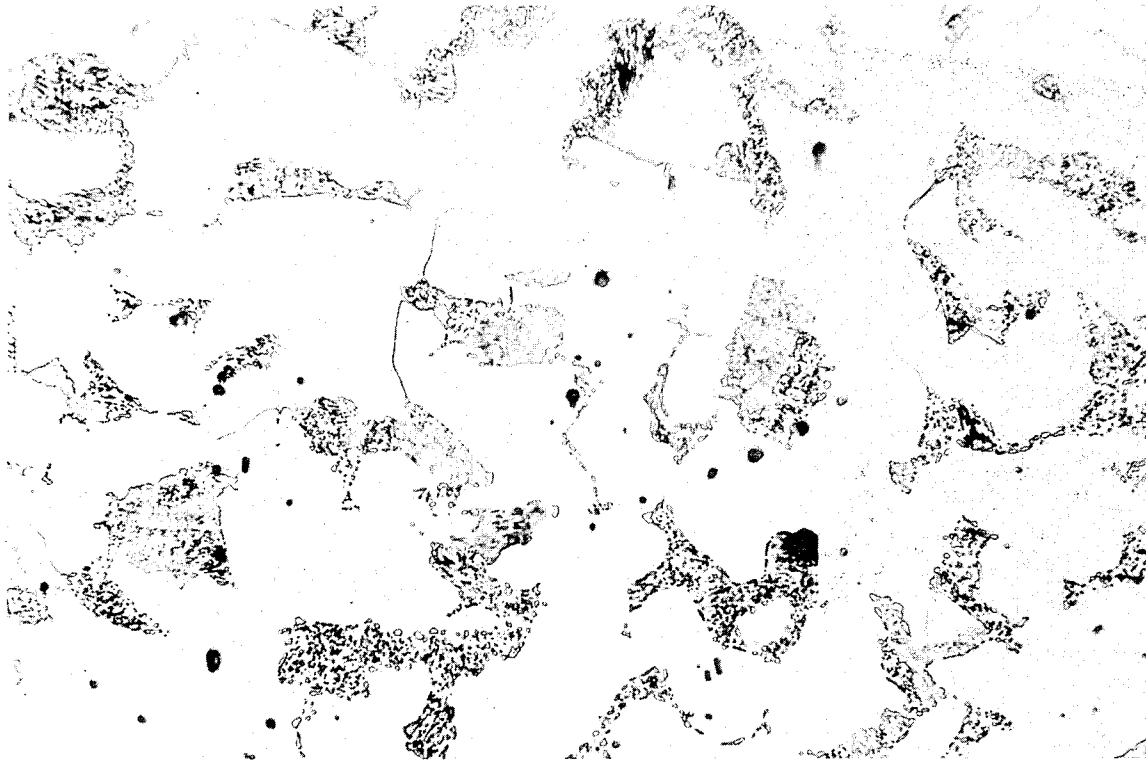
- Fig. 4 - 1B Boiler - RW No. 18 (Section adjacent to bulge). Note coarse carbides; no evidence of partial austenitization is present. Etchant: 1% Nital plus 2% Picral. 1000X.

Fig. 4 - 1B Boiler - RW No. 18 (Section adjacent to bulge). Note coarse carbides; no evidence of partial austenitization is present. Etchant: 1% Nital plus 2% Picral. 1000X.
